PFAS Contamination in Surface Water Samples taken from the Colorado River and tributaries in Bastrop County, December 2022

Molly O'Neil Fisher

Environmental Stewardship

02/11/23

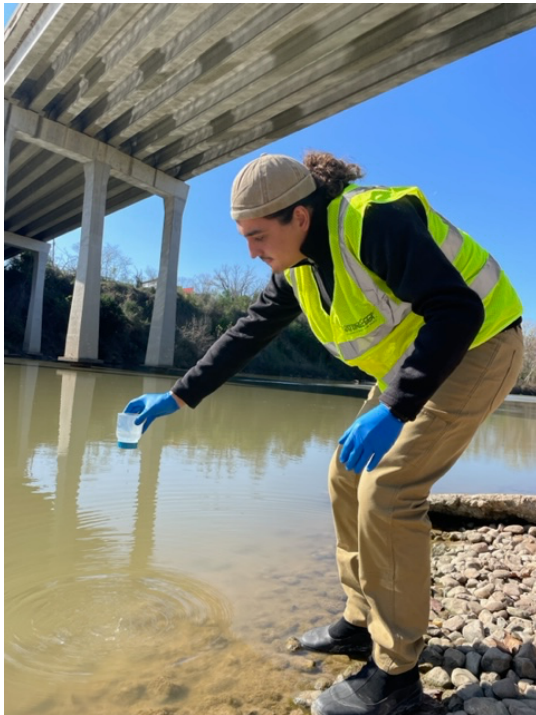
Image 2: Sample Collection at Colorado River at Smithville (ES-4)

Once all the location and sample data were recorded, water samples were collected directly into the Cyclopure sample cup. When taking the sample, the cup was faced up-stream with little to no disturbance of the river/stream bottom. Each water sample cup was filled to the 250 ml line and the lid was placed directly back onto the cup immediately after the collection of water. Once all collected water was filtered through the testing kit, which took roughly about 15-20 minutes depending on turbidity, they were sealed, labeled, and returned to Cyclopure labs for analysis.

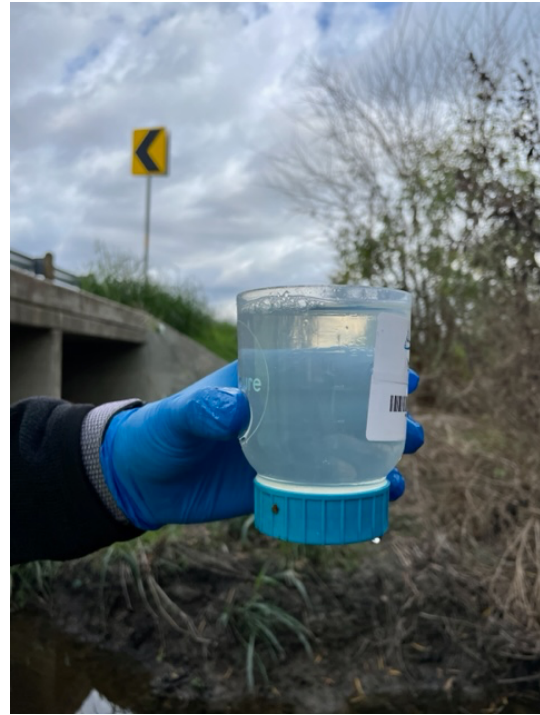
Image 1: Cyclopure Water Test Kit in Use at Decker Creek (ES-3)

ES worked with Cyclopure labs for PFAS testing of water samples. All eleven samples discussed in this report were collected with a Cyclopure product called Water Test Kit Pro. These kits do not require the collecting and shipping of large water samples, rather water is filtered through Cyclopure's patented filtration device DEXSORB®. This lab uses an isotope dilution method to determine the existence of 55 PFAS chemicals, including all listed in EPA health advisories. Cyclopure is not a certified lab, therefore these results serve as preliminary information and demand further inspection by a certified lab to be considered by state and federal regulatory agencies. For more information on Cyclopure's patented technology and laboratory efficacy, please consult their website⁴.
